# Application of Institutional Control Measures and Monitored Natural Attenuation in a Former Industrial Facility

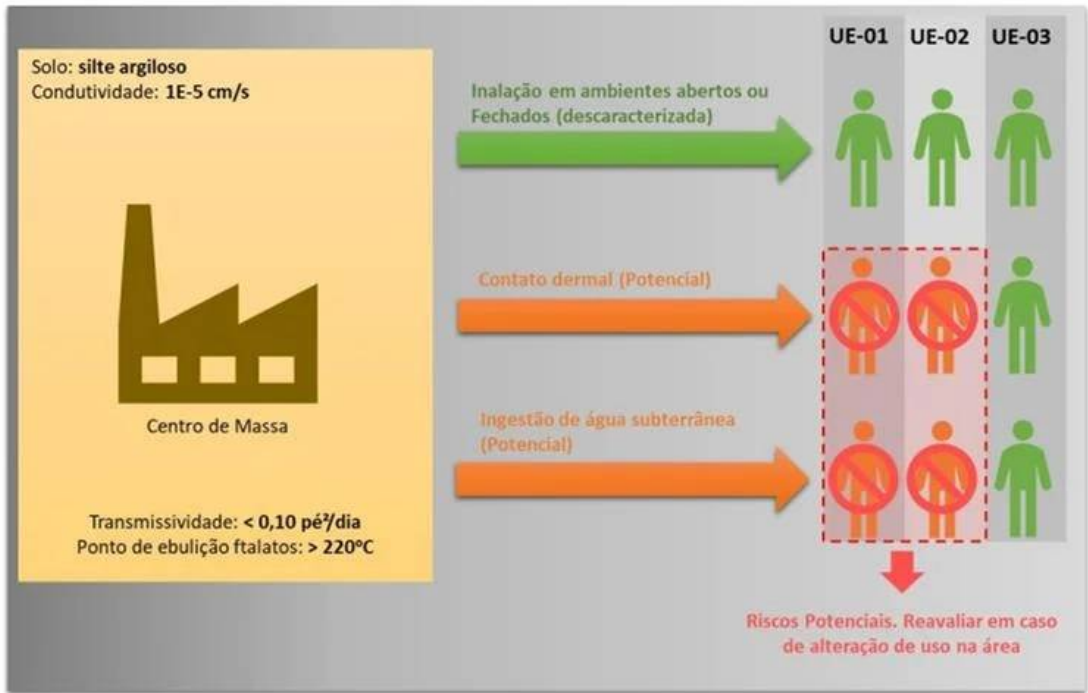
Figura 2.5.1. – Representação Gráfica Sintética do Modelo Conceitual Ambiental

The local soil is characterized by backfill followed by weathered soil, both composed mainly by clayey to silty soil. Hydraulic tests and high-resolution investigation HPT (Hydraulic Profile Tool) showed hydraulic conductivity around 1E-5 cm/s. At the same time, skimming-tests results revealed low transmissivity ( $<0,1 \text{ ft}^2/\text{day}$ ), resulting in low potential for free phase recovery considering hydraulic and pneumatic techniques.

Furthermore, the compounds of concern have physical-chemical properties characterized by high partition coefficients ( $K_{oc} > 1\text{E}+05 \text{ L/Kg}$ ) that imply low mobility and high adsorption to the soil. They also have high boiling points ( $>220 \text{ }^\circ\text{C}$ ) and low vapor pressure (around 1E-07 mmHg at 25°C), which per se makes unfeasible the application of any thermal technique.

The mathematical modeling results show low potential for the plume to reach neighboring properties due to the low transport velocity of the modeled compound - nearly 1 m/year.

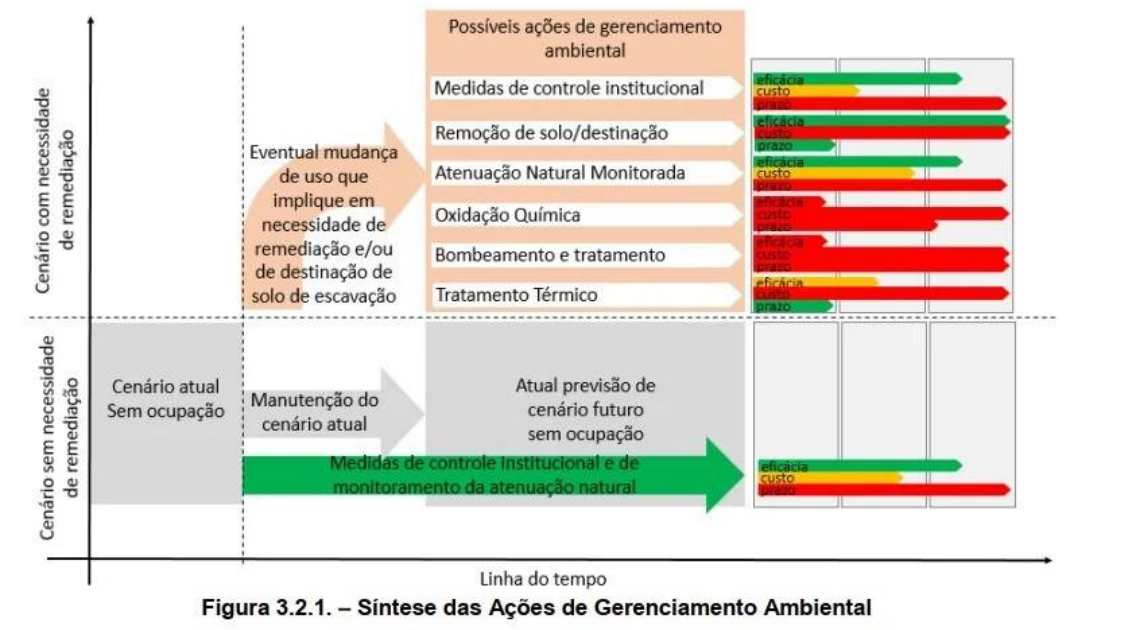
Figura 3.2.1. – Síntese das Ações de Gerenciamento Ambiental

Even with an estimated mass of 15 tons of contaminants within the subsurface, investigations and mathematical modeling results, associated to physical-chemical characteristics of these compounds proved that alternatives considering removal or mass destruction of compounds (pump & treat, excavation and destination, thermal treatment, and chemical oxidation) are technically and financially unfeasible.

Therefore, institutional control measures alongside monitored natural attenuation proved to be the most feasible approach considering that studies indicate a potential for biodegradation of the compounds of concern.
